THOUSAND ACRES SITE NO. 1 DAM
NEW ENGLAND DIVISION, CORPS OF ENGINEERS

PHASE I INSPECTION REPORT NATIONAL DAM INSPECTION PROGRAM

OCTOBER 1964

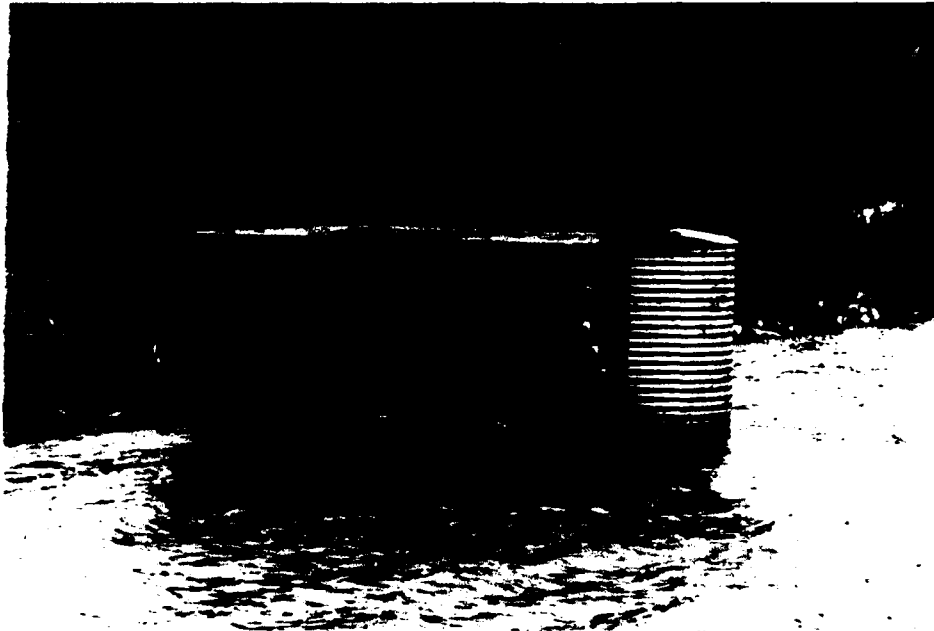
**NO. 5 CONCRETE INTAKE STRUCTURE AND GATE STEM
ON LOW LEVEL OUTLET**

The concrete on the intake structure is in good condition. Minor spalling and erosion has occurred along the normal pool level. There is minor efflorescence of the concrete in this area.

The low level outlet was submerged and not visible. The sluice gate stem is enclosed in a gate well. The hand wheel to operate the sluice gate was not in place, therefore its operability could not be determined. Minor rusting was noted on the sluice gate shaft. No seepage through the sluice gate was observed.

b. Weir	Rectangular orifices on sides of concrete intake structure
General Condition of Concrete	Good-minor spalling and erosion at normal pool level
Rust or Staining	Minor staining visible
Spalling	Minor at normal pool level
Any Visible Reinforcing	None
Any Seepage or Efflorescence	None
Drain Holes	None

c. Intake Structure	Concrete rectangular drop inlet that leads to discharge pipe
General Condition	Good-minor erosion and staining at normal pool level
Loose Rock Overhanging Structure	None
Trees Overhanging Structure	None
Floor of Structure	Clear of debris and silt

- a. Operating and Maintenance Procedures. It is recommended that the Owner accomplish the following:
 - (1) Determine the operability of the sluice gate and, if necessary, restore the low-level outlet to good operating condition. This should include clearing of any silt or debris from the outlet pipe. The operability of the low-level outlet and sluice gate should be checked as part of the annual technical inspections.
 - (2) Clear trees and brush from the area at the downstream end of the emergency spillway channel.

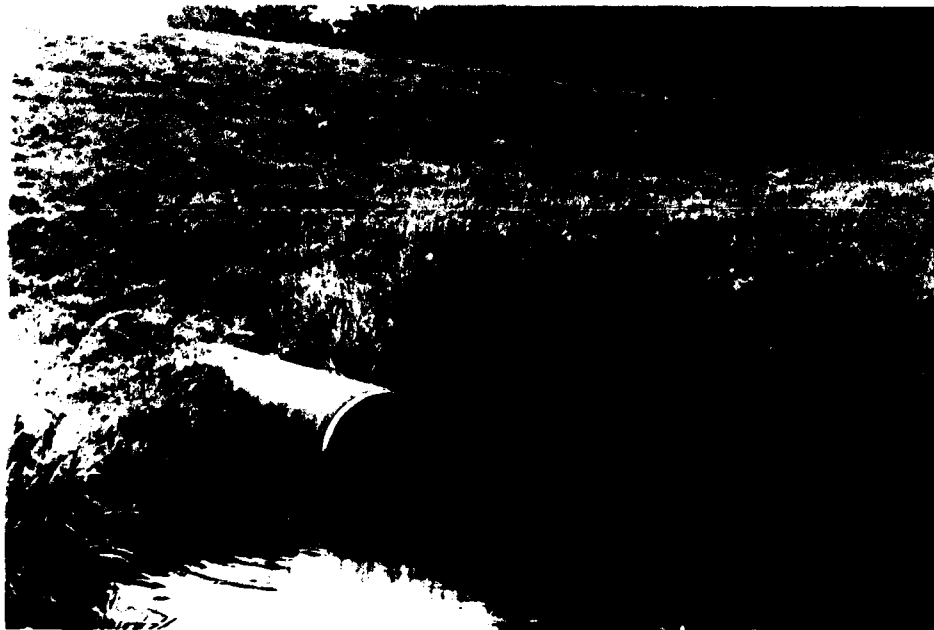
NO. 6 DISCHARGE PIPE AT DOWNSTREAM TOE OF DAM

The discharge pipe is only visible at the intake and outlet ends. Some debris was noted near the intake and minor siltation was visible near the outlet. Moderate flow was noted at the time of the inspection (see Photo No. 6).

AREA EVALUATED	CONDITION
<u>OUTLET WORKS - DISCHARGE PIPE AND DOWNSTREAM CHANNEL</u>	36-inch diameter prestressed concrete pipe - good
<u>General Condition of Concrete</u>	
<u>Rust or Staining</u>	Minor staining near current water level
<u>Spalling</u>	None visible
<u>Erosion or Cavitation</u>	None visible
<u>Visible Reinforcing</u>	None visible
<u>Any Seepage or Efflorescence</u>	None visible
<u>Condition at Joints</u>	Unknown
<u>Drain Holes</u>	None visible
<u>Channel</u>	Unlined stream bed surrounded by flat swamp
<u>Loose Rock or Trees Overhanging Channel</u>	Some small trees and brush along edge of channel
<u>Condition of Discharge Channel</u>	Flat and unlined-some silt accumulated near discharge pipe.
